Monitoring Data Record

Project Title: I-306 DB (I-85 in Durham) COE Action ID: 200020902
 Stream Name: South Ellerbee Creek (Sites 2 & 13) DWQ Number: 001040
 City, County and other Location Information: I-85 from W. of Broad St. to W. of Camden Ave. in Durham County
 Date Construction Completed: n/a Monitoring Quarter: (4) of 4
 Ecoregion: _____ 8 digit HUC unit 03020201
 USGS Quad Name and Coordinates: _____

South Ellerbee Creek

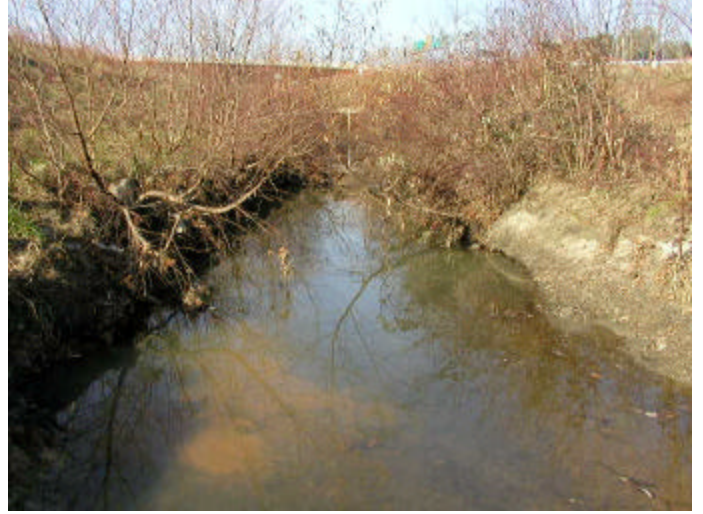
PP #7 Upstream (STA. 4+800-L- LT.)

ADDITIONAL COMMENTS: Vegetation is dormant for the 4th quarter of monitoring. South Ellerbee Creek is highly vegetated throughout the entire length of the stream restoration project, except for the lower end of the stream relocation at Sta. 4+800-L- LT . The stream relocation at this station will need some supplemental planting during the next planting window. The vegetation noted onsite included black willow, silky dogwood, green ash, sycamore, sweetgum, tulip poplar, wax myrtle, pine, mimosa, elm, river birch, lespedeza, smartweed, jewelweed, goldenrod, fennel, *Juncus* sp., sedge, ragweed, and various grasses.

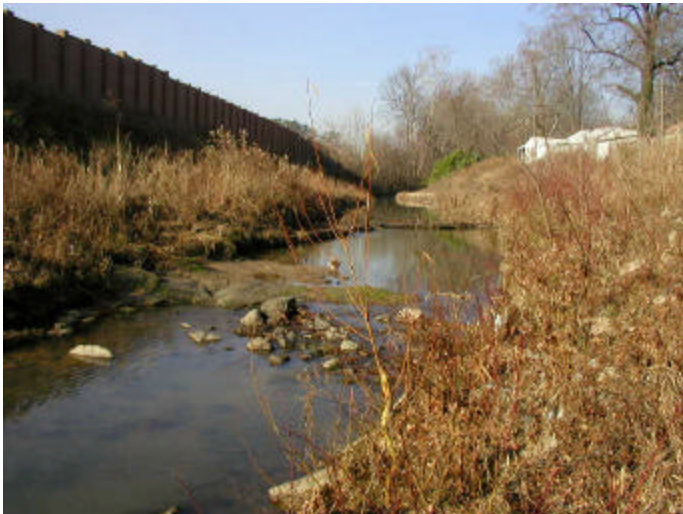
PP #12 Upstream (STA. 6+000-L- LT.)

| Date Inspected | 12/14/06 PP #12 Upstream Sta. 6+000-L- LT. | | |
| Bank or scour erosion present? | Yes | | |
| Other problems noted? | Old culvert footing in stream will be altered so that it is not directing water flow into left bank. | | |
